GelSight Applications in Aerospace

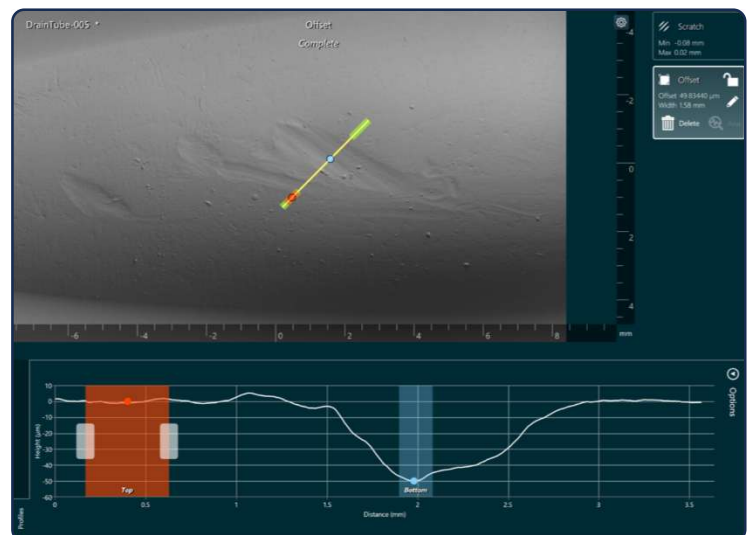
Use functions like Offset, Scratch, or Defect Detection to characterize defects. GelSight can analyze defects on flat, curved, and complex geometries, allowing for in-situ data collection on traditionally challenging to measure surfaces. Measure damage and wear on internal engine parts, scratches on transparent windows, lightning strikes on fuselage, and dents on drain lines with the same tool and no required settings changes.

Figure 2: Offset function used to measure the depth of a dent on a CFM56 drain line

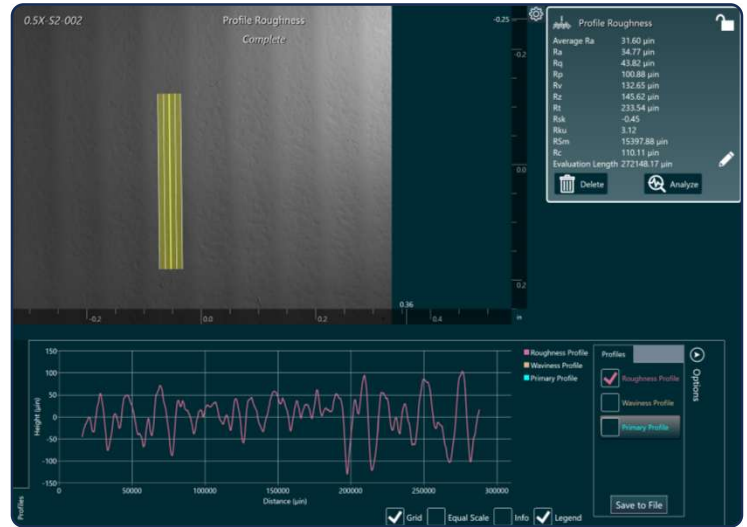
Use the Profile Roughness or Surface Roughness functions to measure parameters, including Ra and Sa, for the characterization of surfaces. The digitized, areal, output of the GelSight system lets the user make multiple measurements on a single scan and save the data for reference and traceability. Surface finish is a key specification on parts including shot peened or media blasted surfaces in MRO.

Figure 3: Using Profile Roughness to measure the Ra of a curved surface on landing gear

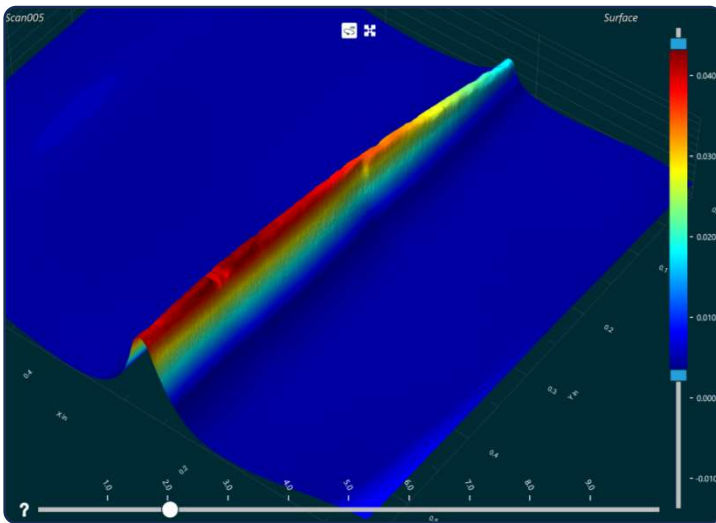
Measure defects, radii, and even roughness on the edges of blades. Features of, or defects on, the edges of blades are typically challenging to measure, and the measurement is made quick and easy with the GelSight system. Press the gel onto the edge of the blade and use the Offset function to measure depths of edge defects in seconds, something that can require significant setup time on other measurement systems. GelSight's 2D tools allow for the creation of shapes and datum to recreate damaged surfaces for characterization with the final report enabling clear communication across organizations.

Figure 4: 3D reconstruction of the edge of a turbine blade with heightmap

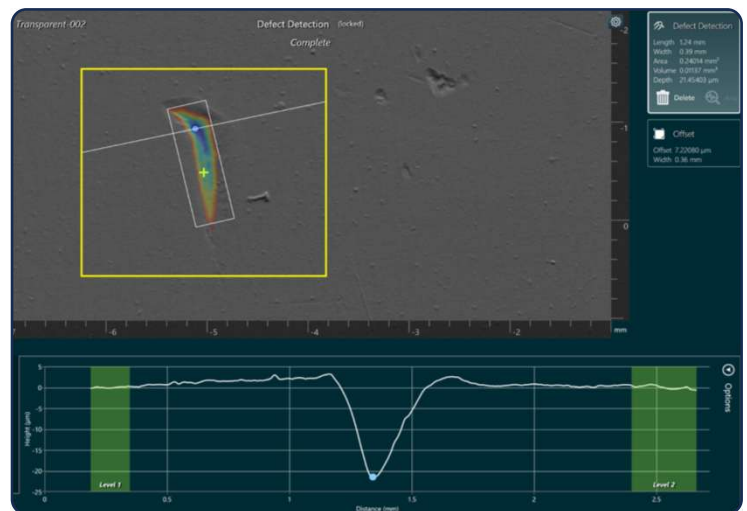
The gel sensor of the GelSight system allows for inspection of Any Material, Anywhere™. This includes surfaces that are highly reflective or transparent. Defects on transparent materials can be captured and analyzed with configured tolerances, allowing the operator to capture scans and receive a visual pass/fail indication. All images and analysis results can be saved for traceability using one-touch reporting, or use the API to automatically feed the data into other systems. GelSight functions encourage users to reference the captured analysis for any secondary investigations and allow for tracking locations and defects over time.

Figure 5: Defect Detection analysis on a transparent cockpit window
